**DEPARTMENT OF TRANSPORTATION**

Contract #: 04-0120F4Cty: SF/ALA Rte: 80 PM: 13.2/13.9File #: 69.28**WELDING INSPECTION REPORT****Resident Engineer:**Siegenthaler, Peter**Address:** 333 Burma Road**City:** Oakland, CA 94607**Report No:** WIR-024005**Date Inspected:** 16-Apr-2011**Project Name:** SAS Superstructure**OSM Arrival Time:** 1500**Prime Contractor:** American Bridge/Fluor Enterprises, a JV**OSM Departure Time:** 300**Contractor:** Zhenhua Port Machinery Company, Ltd (ZPMC), Changxing Island **Location:** Shanghai, China**CWI Name:** Mr. Li Yan Hua**CWI Present:** Yes No**Inspected CWI report:** Yes No N/A**Rod Oven in Use:** Yes No N/A**Electrode to specification:** Yes No N/A**Weld Procedures Followed:** Yes No N/A**Qualified Welders:** Yes No N/A**Verified Joint Fit-up:** Yes No N/A**Approved Drawings:** Yes No N/A**Approved WPS:** Yes No N/A**Delayed / Cancelled:** Yes No N/A**Bridge No:** 34-0006**Component:** OBG**Summary of Items Observed:**

## WELDING INSPECTION REPORT

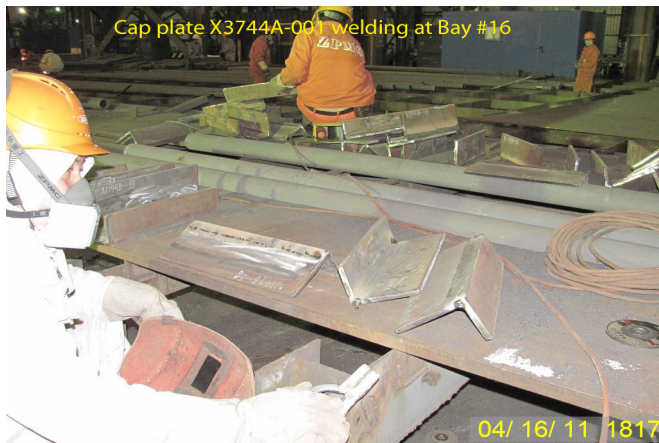
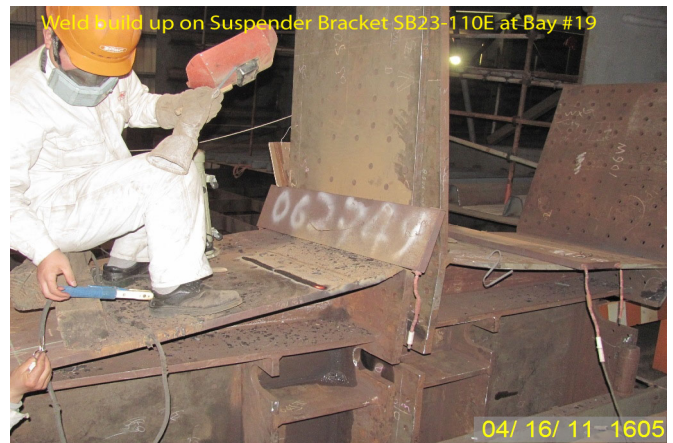
For further information see below pictures:-

Unless otherwise noted, all work observed on this date appeared to be in general compliance with the applicable contract documents.
